STATIC AND DYNAMIC TESTS OF CUYUTLAN VIADUCT

An extensive program of static and dynamic tests was performed on the new *Cuyutlan Railway Viaduct* before its opening to traffic. The viaduct is a prestressed concrete bridge of 8568 m length located on the Cuyutlan lagoon near of Manzanillo port on the Pacific coast of Mexico. The construction zone included some geotechnical challenges and is located in a high risk seismic zone. A series of tests were done to the bridge using of a fully loaded train of 5200 tons. The dynamic and static behaviour was measured in several points along the bridge considering service (normal circulation of full loaded trains) and accidental conditions (emergency braking of the train on the bridge). Measured accelerations and displacements in different directions were compared against those specified in design codes. The tests also included a detailed inspection of the full bridge *before* and *after* the test campaign in order to detect any damage over the structure originated by service loads. The bridge behaviour was satisfactory and it was open to traffic on 2011.

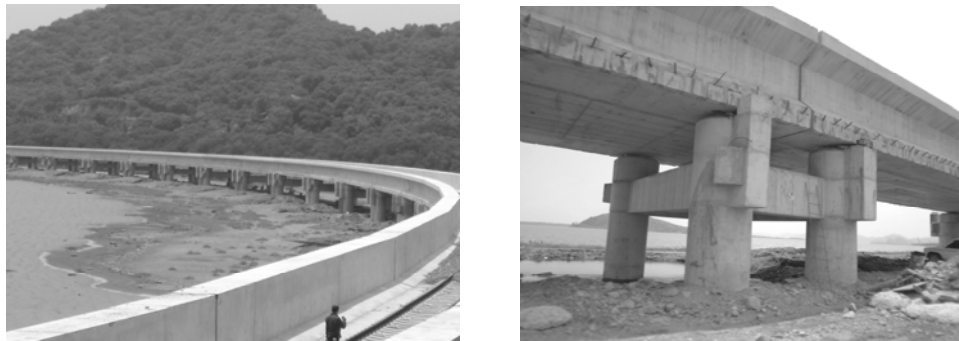
The bridge has 306 simply supported spans of 28 m length. The viaduct has 307 piers, each pier of the viaduct is formed by 4 reinforced concrete cast in place piles (figure 3 and 4).

Figure 4 : General view of the deck and view of a typical pier

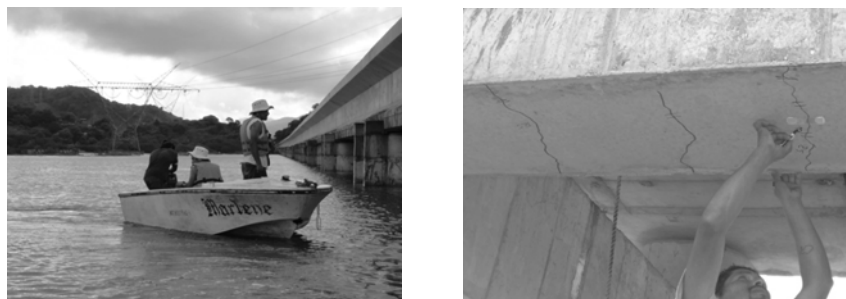
A detailed inspection of the entire bridge was carried out before and after the pre-operative period. These work included a detailed review of all structural elements of the bridge (figure 5). Any damage found (cracks and fissures) were marked and measured, and placed in a report. A comparison of the results of the inspection before and after pre-operative period was made. Furthermore, detailed topographic surveys were conducted across the bridge before and after the pre-operative period (figure 6), and were compared in order to detect possible settlement or deformation originated by service loads.

Figure 5 : Inspection work and detection of small cracks.

The damages found were the result of the construction of the bridge (small cracks), and not because from the passage of trains over the bridge. On the other hand, permanent deformation and settlements induced by service loads were negligible.

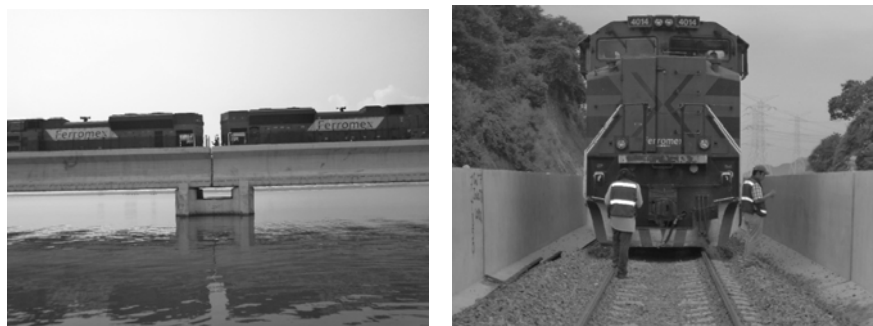
The load used for these tests was a tandem of two locomotives of 194 tons each.

Figure 8 : Static test

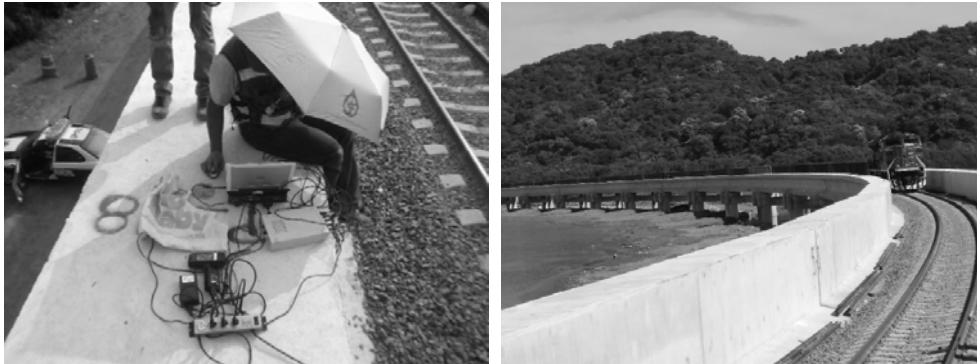
The sampling frequency during the tests was fixed at 512 Hz. The duration of the measurement was subject to the type of test and train speed. In all cases the test was started about 30 seconds before the passage of the train. In general, the duration of test varied from 100 to 200 seconds.

Figure 10 : Measurement equipment, and train passing over a test site

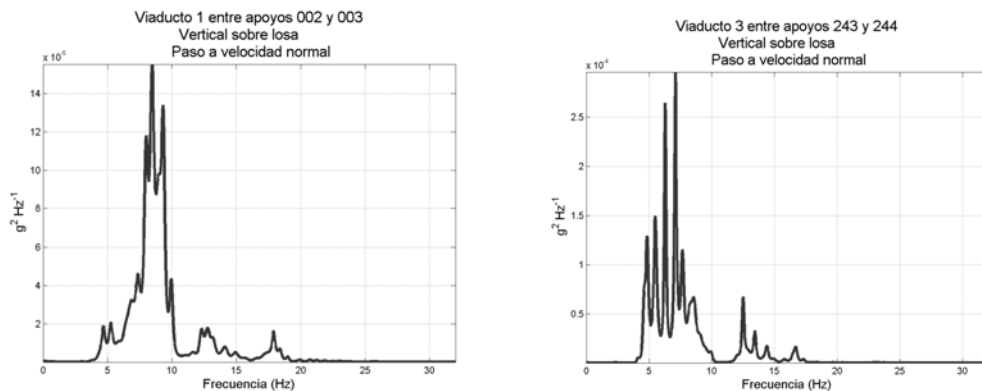
Some of the typical results obtained during the dynamic tests campaign are shown on figures 11 and 12. Using the Power Spectral Density (PSD) functions, it was possible to estimate the vertical vibration period of the bridge span tested (Bendat and Piersol 2000). The values were bounded between 6 and 9 Hz (see figure 13).

Figure 13 : PSD of vertical accelerations at mid span for standard speed test over spans 2-3 and 243-244

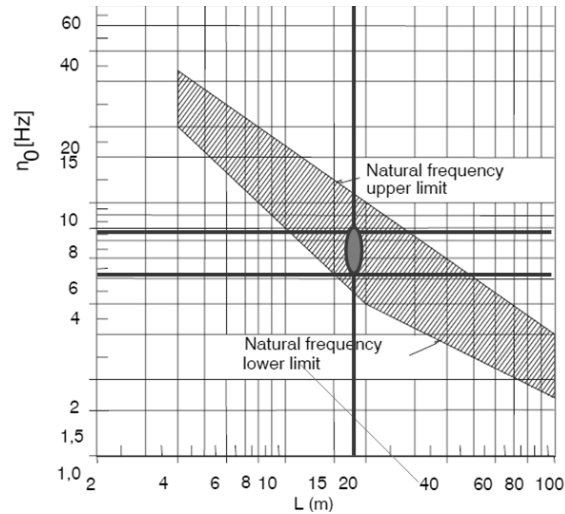
There are several international recommendations to limit vibration levels (acceleration) of railway bridges. In this work it was investigated three different international standards: Eurocode 1 2004, IAPF 2010, and UIC Code 776-2 2009. All studied codes have similar restrictions to the allowable vibration levels in railway bridges. The first review concerns the verification of the frequency of vibration of the structure as a function of the span. Figure 14 shows the verification of this criteria according to Eurocode 1 using the measured vertical vibration frequencies estimated for the bridge deck. If the structure under consideration is inside the limits indicated, there will be no resonance phenomena that endanger the movement of trains on it. This recommendation applies to bridges with "normal" typologies, as in the case of the Cuyutlan Viaduct.

On the other hand, when the risk of resonance is possible, or the type of bridge is considered atypical, vertical peak accelerations are limited to 0.35 g, for bridges on ballast.

Figure 14 : Verification of vertical vibration criteria of railway bridges according to Eurocode 1
